TECHNICAL REPORT ARCCB-TR-95022

FRACTURE TESTING OF METALS AND COMPOSITES: TESTS AND ANALYSES FOR FAILURE PROBLEMS WITH ARMAMENT COMPONENTS

J.H. UNDERWOOD

MARCH 1995

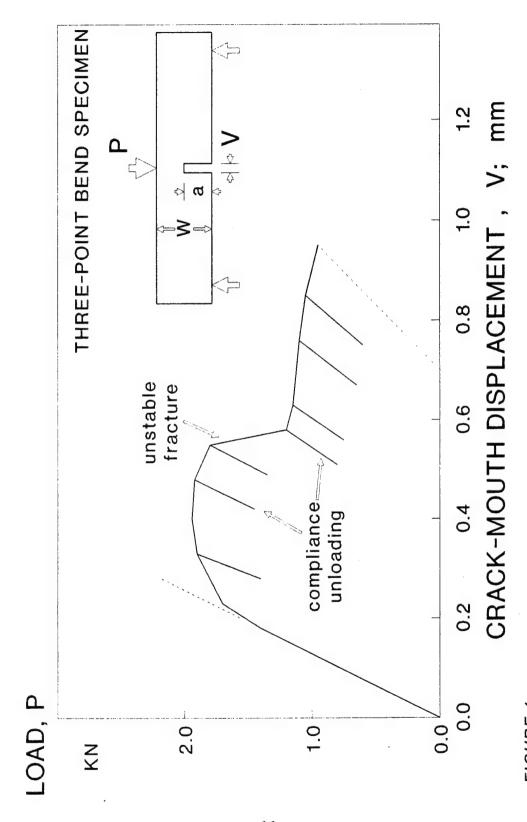
Figure 1 shows the key elements of a compliance unloading J_{Ic} test used in failure analysis of a stainless steel welded structure (ref 4). Some details are given later. Two important points for the topic here, summarized in Figure 1, are as follows. First, the three-point bend configuration, generally regarded as quite simple to test, can now be used with a single, direct displacement measurement, V, at the crack mouth. Recent work (refs 5,6) has shown that V can be used for J calculation as well as its accepted use in compliance unloading. This avoids the difficulties with measuring load-line displacement. Second, the compliance-unloading method allows crack growth measurement throughout the test. The test in Figure 1 used a relatively small specimen, with W = 10 mm, so that the crack growth caused large increases in crack length, a, relative to W, and the decrease in slope of the unloads related to the increase in a/W

can be clearly seen. Note that even the occurrence of unstable cleavage fracture during the test can be described by the unloading compliance method.

FIGURE 1 J_{ic} test of 15-500 PH stainless steel weld; welded and aged at 593 C

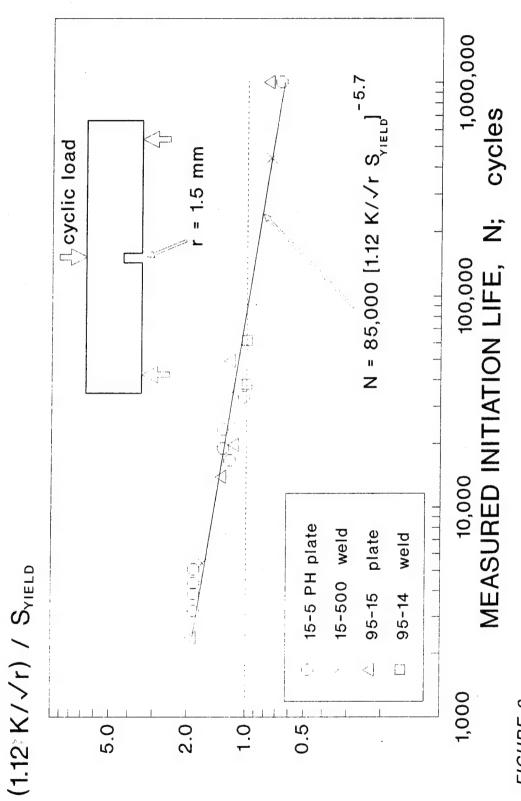
A summary of fatigue initiation results for the same welded structure mentioned previously (ref 4) is shown in Figure 2. The K/\sqrt{r} analysis used by Barsom and Rolfe (ref 2) for low and medium strength steel structures gives a good description of the measured fatigue initiation lives for bend specimens of four different weld and plate samples of high strength stainless steel. The quantity $(1.12 \ K/\sqrt{r})$ is a good estimate of the maximum stress at the notch root, based on the stress intensity factor, K, and the notch root radius, K. By using the ratio of the maximum notch root stress to material yield strength, an S-N plot of results from four different materials gives a single trend line that can be used for descriptions of fatigue initiation life and for life predictions for the courageous.

FIGURE 2 Fatigue life tests and analysis of PH stainless steel welds and plate

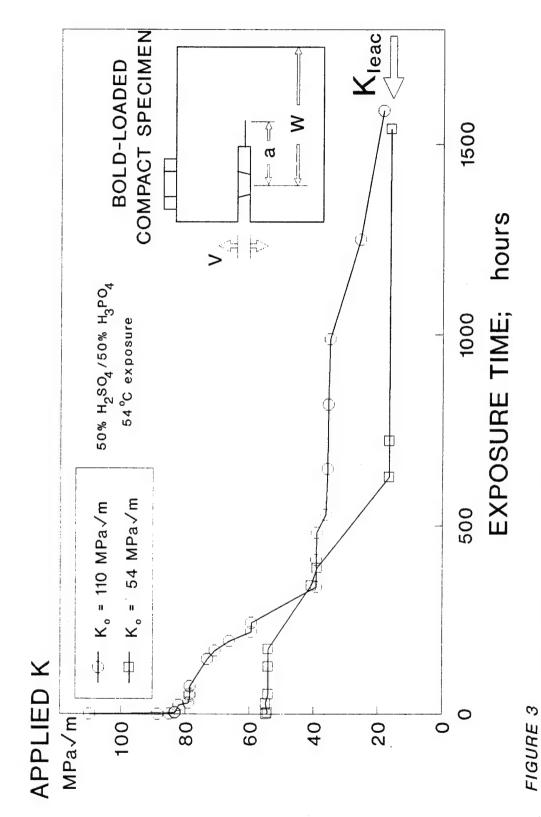
Test and analysis methods for describing environmentally-assisted cracking are addressed in Figure 3. Shown are the bolt-loaded compact test configuration and applied K versus exposure time results for environmental cracking in a nickel-chromium-molybdenum high strength steel (ref 7). The bolt-loaded test is both simple and portable, which are considerable advantages when dealing with aggressive environments such as the warm acids in this example. An accurate K expression is available in terms of crack mouth displacement, V, rather than in terms of load, P, as is typical. As the crack grows with increasing exposure time, the applied K value decreases until a constant value is obtained, and this gives the value of K_{leac} , the threshold K for environmentally-assisted cracking for this material and environment. Note in the results here the starting value of applied stress intensity factor, K_o , has no effect on K_{leac} , because considerable crack growth has occurred at low K and the crack has grown beyond any effect of the prior higher K_o value.

Kleac tests of 1210 MPa yield strength NiCrMo steel in acid environment

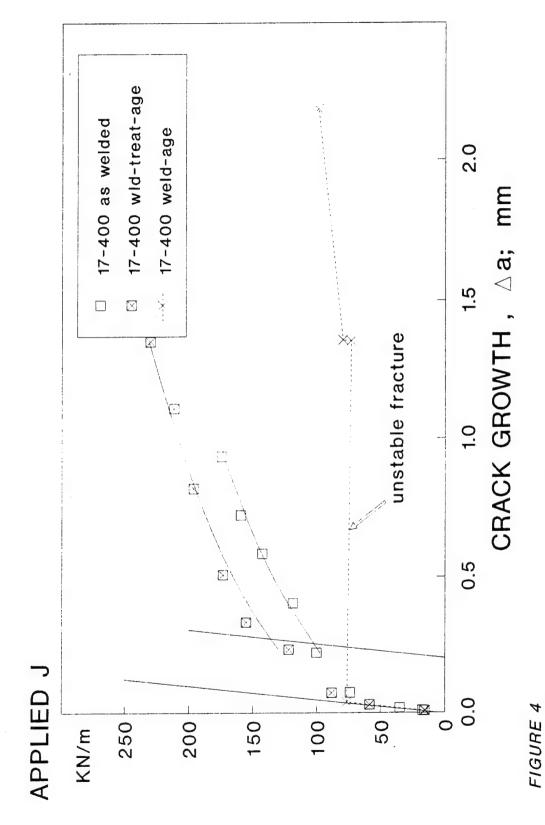
Results are shown in Table 1 for three heat treat conditions of 17-400 precipitation hardening stainless steel weld metal (AMS 5825 specification). As anticipated, the lowest initiation lives were obtained for the welds where the solution heat treatment was omitted, as sometimes happens in the case of a weld repair. The subsequent $J_{\rm Ic}$ tests also showed this

omission of the solution heat treatment to give the worst results. The applied J versus Δa plots from which the J_{Ic} values were obtained are shown in Figure 4. Note that, as in the similar case discussed in relation to Figure 1, unstable cleavage fracture occurred for the weld-age heat treatment, leading to the lowest J_{Ic} value. In addition, the J values beyond the J_{Ic} point, such as at $\Delta a = 1$ mm (in Table 1), are significantly lower for the weld-age treatment.

Failure of a welded stainless steel beam emphasized the importance of the proper heat treated condition for obtaining high fracture toughness and high fatigue life. Omission of the solution heat treatment resulted in the lowest J_{Ic} value, the lowest J-R curve, and the lowest fatigue initiation lives.

J_{1c} tests of 17-400 PH stainless steel welds with various heat treatments

As a result of the failure investigation of the welded cannon carriage, it was recommended to use deeper penetration welds, to perform the complete solution treat and ageing procedure whenever possible, or if not possible, then to apply much stricter inspection criteria to the carriage.

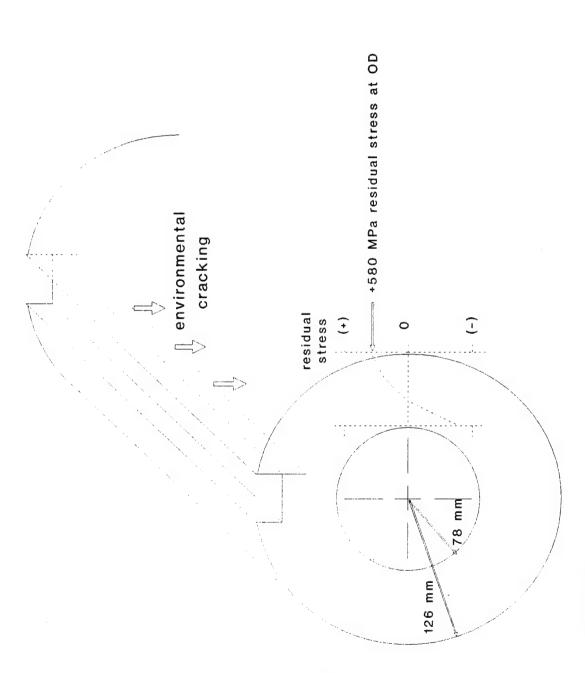
A quite unanticipated failure of a cannon tube occurred during a chromium plating process (ref 7). The tube was under no externally applied load whatsoever, and still a 1.7-m long crack grew entirely through the 48-mm thick wall of the tube. The test conditions eventually found to be crucial are shown in Figure 5 and listed in Table 2. The tube had a notch on the outer surface whose severity is only a little exaggerated (for clarity of presentation) in Figure 5. The tube also had circumferential direction tensile residual stress at the outer surface of about 580 MPa, due to an autofrettage procedure. The notch and residual stress combined to produce a yield strength level sustained tensile stress at the notch roots.

Sustained yield strength level stress alone could not have caused the failure of the A723 (ASTM specification) steel used for the tube. The steel had considerable fracture toughness, as indicated by the values of V-notched Charpy impact energy and fracture toughness in Table 2. It was the aggressive warm acid environment (see Table 2) combined with the sustained tensile stress that caused the failure. The sulfuric and phosphoric acid mixture at 54° C was used for electropolishing the steel before plating. Environmentally-assisted cracking was found to occur in this acid environment at values of applied K as low as about 20 MPa \sqrt{m} in the tests described earlier in relation to Figure 3. This is only one-sixteenth of the value of fracture toughness--the applied K at which cracking is expected in response to a single or sustained load without assistance from an aggressive environment.

An unanticipated failure of a cannon tube during a plating process showed that when the basic requirements for environmentally-assisted cracking are present, loading and material conditions normally considered safe can be brushed aside. Even though the tube had good inert environment fracture toughness and no external loads, a complete structural failure occurred due to the presence of a notch, a tensile residual stress, and an aggressive acid environment.

FIGURE 5 Environmental cracking at an OD notch in a cannon with tensile residual stress

As a result of the investigation, it was recommended to prevent or minimize contact of the acid with the notch root, if practical, or to significantly increase the notch root radius in order to reduce the value of sustained tensile stress.
